Manhole Inspection Summary

Manhole # S31SS_049MH

Insp Date: **6/13/07 10:09 AM**

Location Address: **2847 HUNTINGDON AVE**

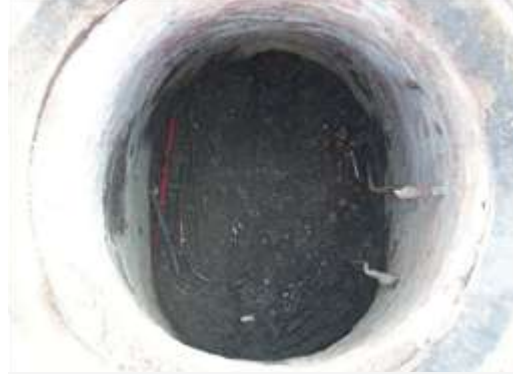
Top View

Corroded and missing steps. Channel debris.

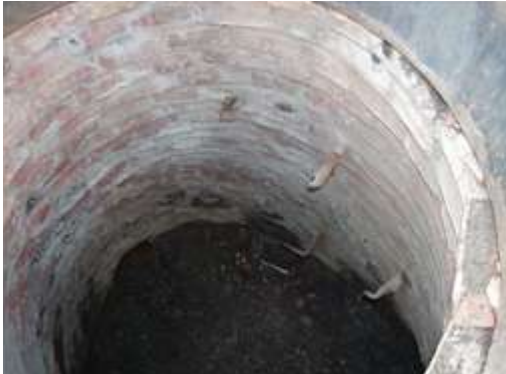
Defect

Frame leaks. Adjustment deterioration and infiltration. Barrel infiltration.

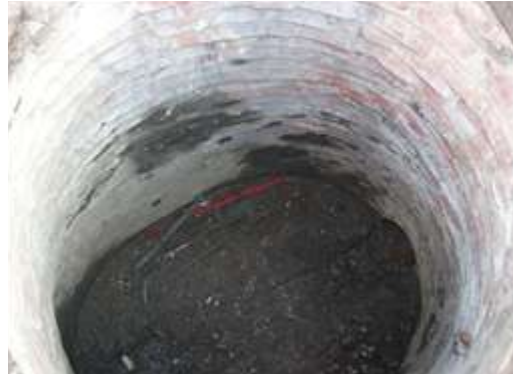
Defect

Barrel infiltration.

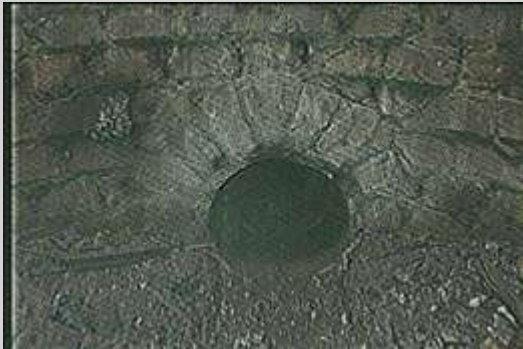
8 in. Circular Gravity Sewer
Pipe Out @ 12 O'Clock

Barrel deterioration and infiltration.
